## TEST REPORT

No. : SZIN2306000976ML01-1\_EN

Sample Name : Cam Lock Fitting

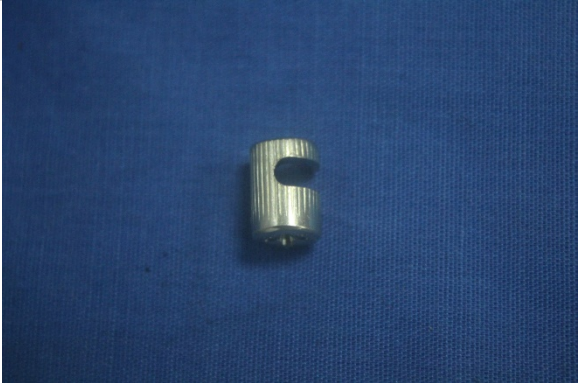
### 1. Compression test of connecting fitting:

Reference method: GB/T 28203- 2011, clause 6.4.1

| Before test | During test |

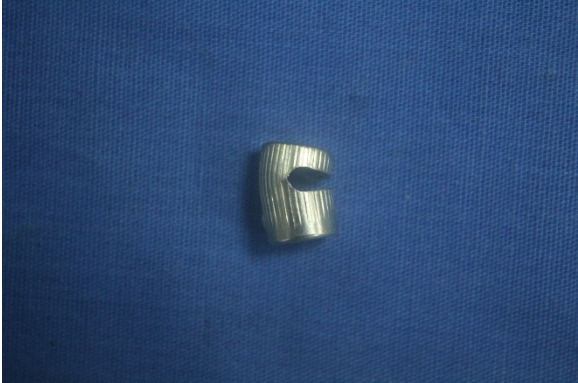
| After test | Test curve |

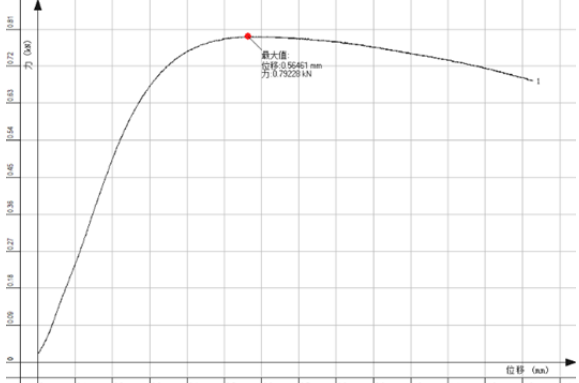
| Sample No. | Requirement | Result (N) | Conclusion |
|---|---|---|---|
| 001 | $\geq 240$ N | 792 | Pass |

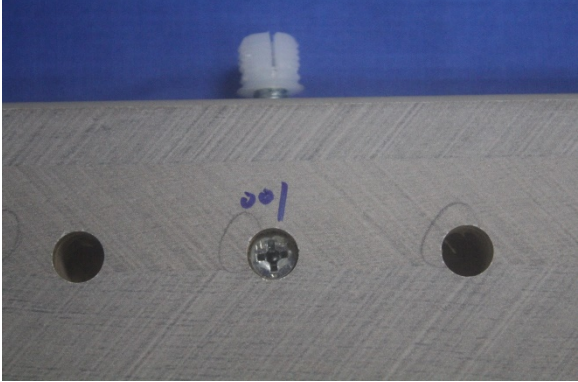
### 2. Torque test of connecting fitting:

Reference method: GB/T 28203- 2011, clause 6.4.4

| Before test | During test |

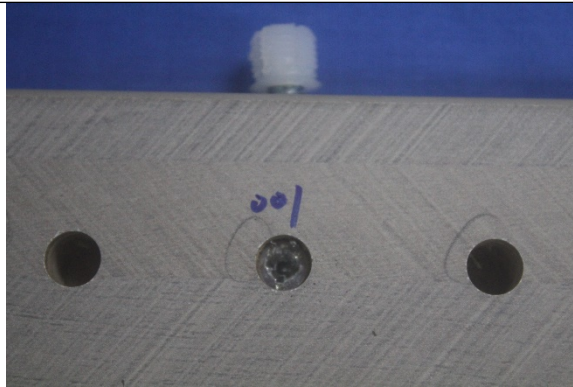
After test

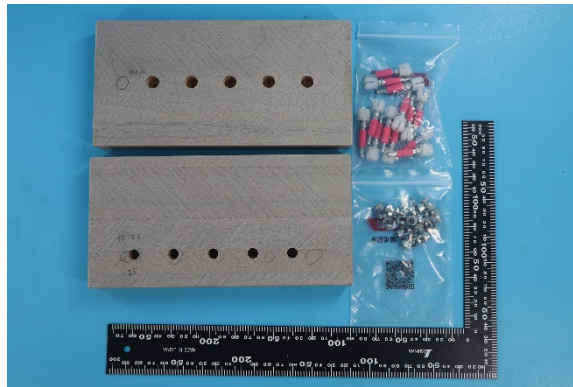
Sample Photo
